Original Issue May 6, 2025
Revised June 9, 2025, with Contra Costa Health MRC Oversight Committee Comments

Draft Final Report
Independent Incident Investigation/Root Cause Analysis
of the
Martinez Refining Company LLC
February 1, 2025 Loss of Process Containment and Fire
for

Contra Costa Health
Attn: Nicole Heath, Michael Dossey

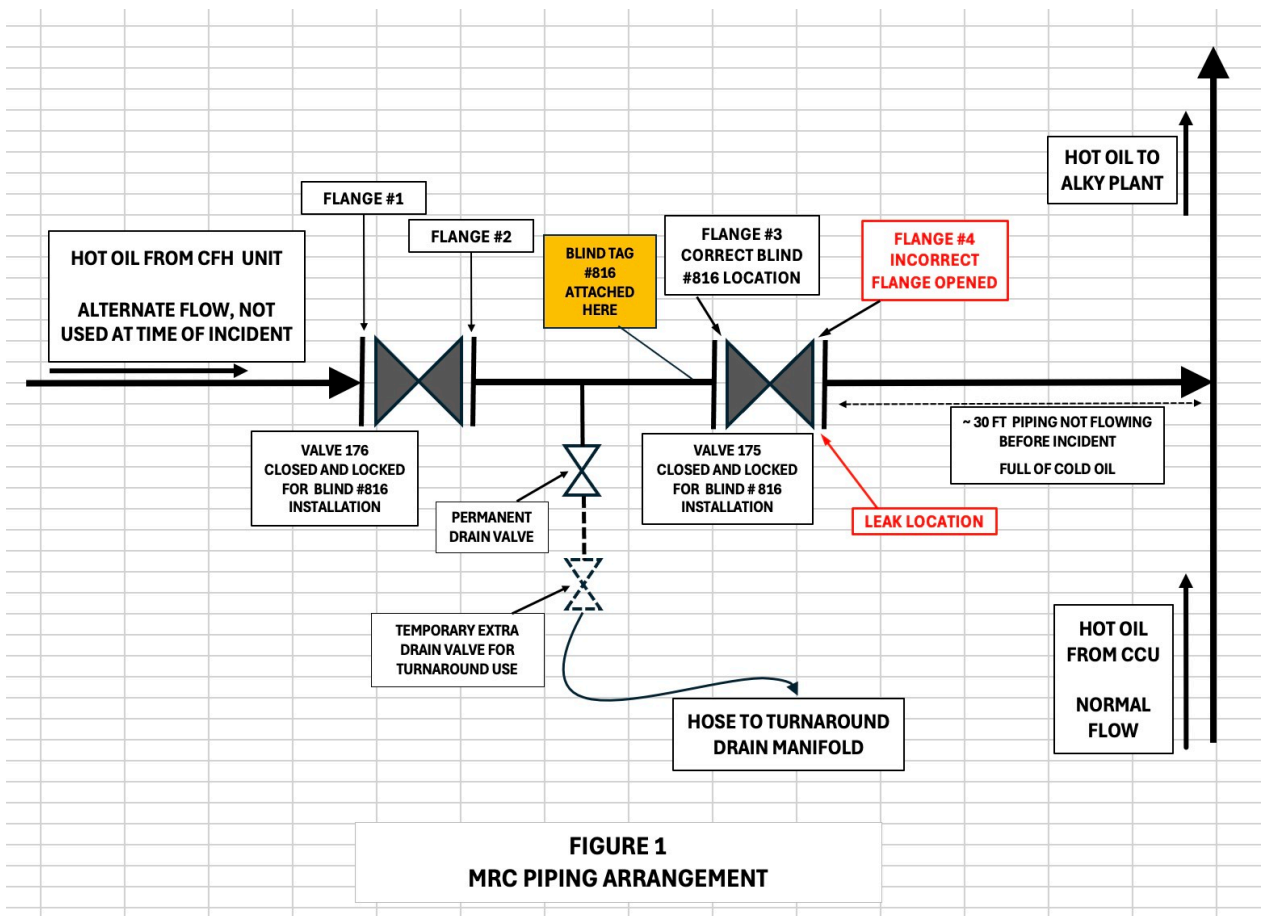
**FIGURE 1
MRC PIPING ARRANGEMENT**

information, JEM concluded the four bottom stud bolts on the incorrect Flange #4 were loosened prior to the loss of containment and fire.¹ The loose stud bolts found on Flange #3 are believed to be loose due to the heat effects of the fire.

Figure 1 is a drawing showing the piping arrangement, including the planned blind installation location at Flange #3. Flange #4 which was incorrectly opened, causing the initial leak.

Piping, flanges, and bolting at the blind #816 location were examined by MRC experts after the fire. The stud bolts on the wrong flange (Flange 4 in Figure 1) were found to have been loosened on the bottom side of the flanges as stated by the TIMEC Steamfitters - which resulted in the fire. Loose stud bolts on the correct flange (Flange #3 in Figure 1) were also noted.

The entire double valve piping assembly was sent to an independent laboratory for metallurgical evaluation and mechanical testing. A summary of breakaway torque measurement data from that testing was provided to JEM by MRC indicated 4 bolts on the bottom of the incorrect flange (Flange #4 on Figure 1) and all bolts on the correct flange (Flange #3 on Figure 1) were loose. An additional summary of independent laboratory results was provided verbally by MRC to JEM in late May. Based on this information, JEM concluded the four bottom stud bolts on the incorrect Flange #4 were loosened prior to the loss of containment and fire, and the bolts on Flange #3 were loosened by heat effects of the fire.²

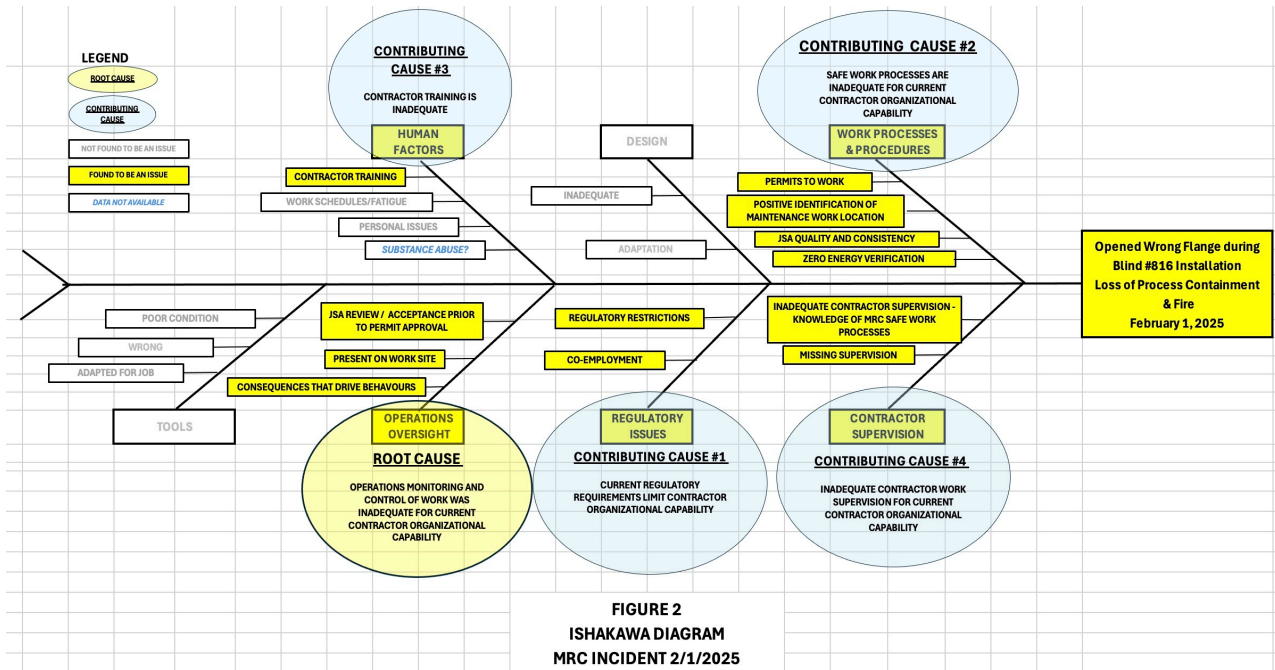
JEM Advisors used the fishbone/cause and effect diagram to identify the incident causal factors and root causes for this event as shown below.

Root Cause- Operations Monitoring and Control of Work was inadequate for current Maintenance Contractor Organizational Capability
