Original Issue May 6, 2025
Revised June 9, 2025, with Contra Costa Health MRC Oversight Committee Comments
Revised September 12, 2025 with Public Hearing Comments (6/17/2025)

Final Report
Independent Incident Investigation/Root Cause Analysis
of the
Martinez Refining Company LLC
February 1, 2025 Loss of Process Containment and Fire

Contra Costa Health
Attn: Nicole Heath, Michael Dossey

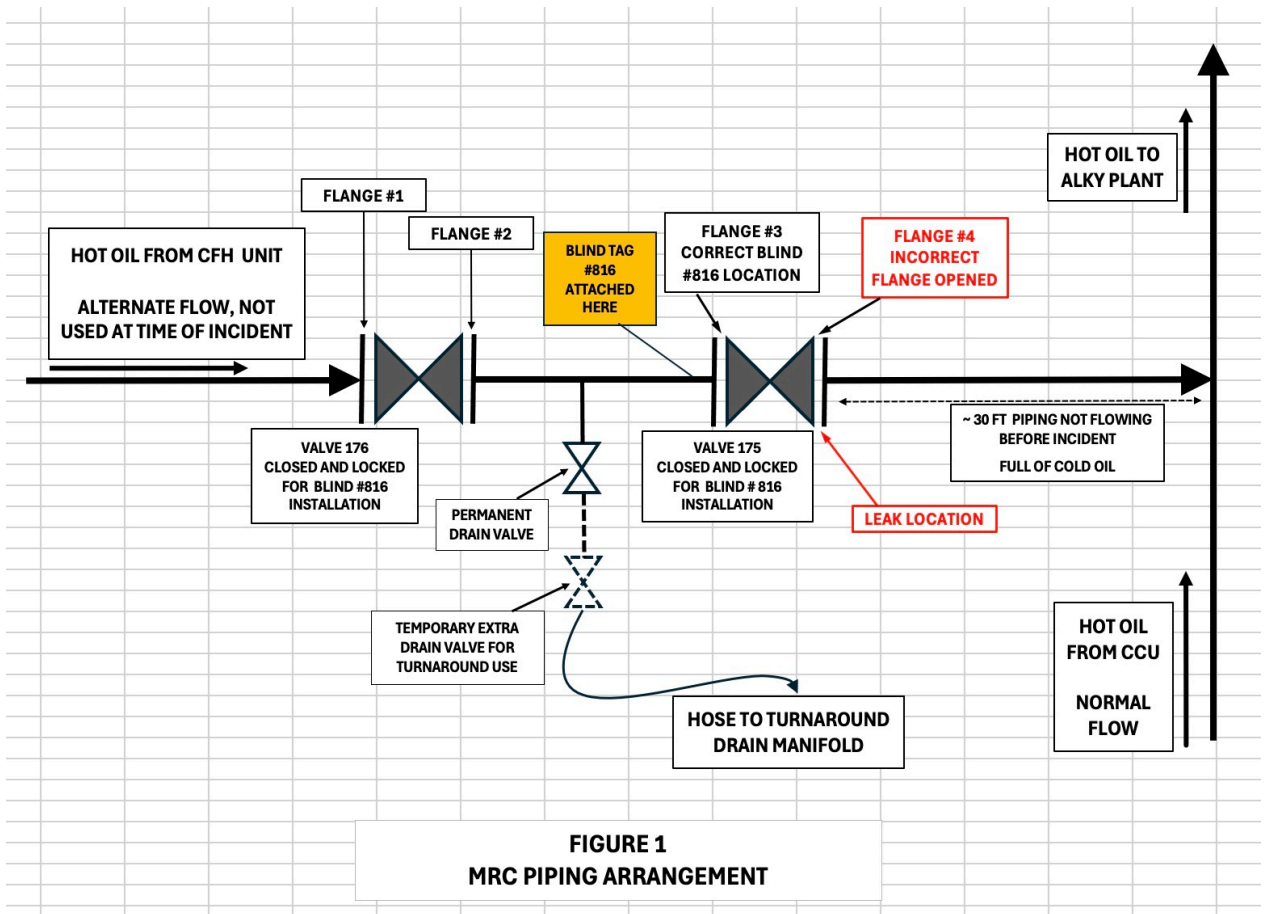
information, JEM concluded the four bottom stud bolts on the incorrect Flange #4 were loosened prior to the loss of containment and fire.¹ The loose stud bolts found on Flange #3 are believed to be loose due to the heat effects of the fire.

Figure 1 is a drawing showing the piping arrangement, including the planned blind installation location at Flange #3. Flange #4 which was incorrectly opened, causing the initial leak.

After loosening four bolts from the wrong flange (Flange #4), hydrocarbon fluid began to leak from the flange. This 'incorrect' set of flanges was part of the active piping system that was moving hot hydrocarbon from the CCU to the Alky at the time of the incident. Unable to stop the leak, the TIMEC Steamfitters evacuated the area. The leak prevented them from leaving the scaffolding via the ladder. The journeyman was able to disconnect his breathing air supply hose and climb down from the short scaffolding using his five-minute escape pack. The apprentice was unable to disconnect his breathing air hose due to oil making the connector slippery, so he climbed down from the scaffold pulling the air hose along with him. The apprentice then removed his harness, escape bottle and mask, and evacuated the area with the journeyman.

Piping, flanges, and bolting at the blind #816 location were examined by MRC experts after the fire. The stud bolts on the wrong flange (Flange 4 in Figure 1) were found to have been loosened on the bottom side of the flanges as stated by the TIMEC Steamfitters - which resulted in the fire. Loose stud bolts on the correct flange (Flange #3 in Figure 1) were also noted.

The entire double valve piping assembly was sent to an independent laboratory for metallurgical evaluation and mechanical testing. A summary of breakaway torque measurement data from that testing was provided to JEM by MRC indicated 4 bolts on the bottom of the incorrect flange (Flange #4 on Figure 1) and all bolts on the correct flange (Flange #3 on Figure 1) were loose. An additional summary of independent laboratory results was provided verbally by MRC to JEM in late May. Based on this information, JEM concluded the four bottom stud bolts on the incorrect Flange #4 were loosened prior to the loss of containment and fire, and the bolts on Flange #3 were loosened by heat effects of the fire.²

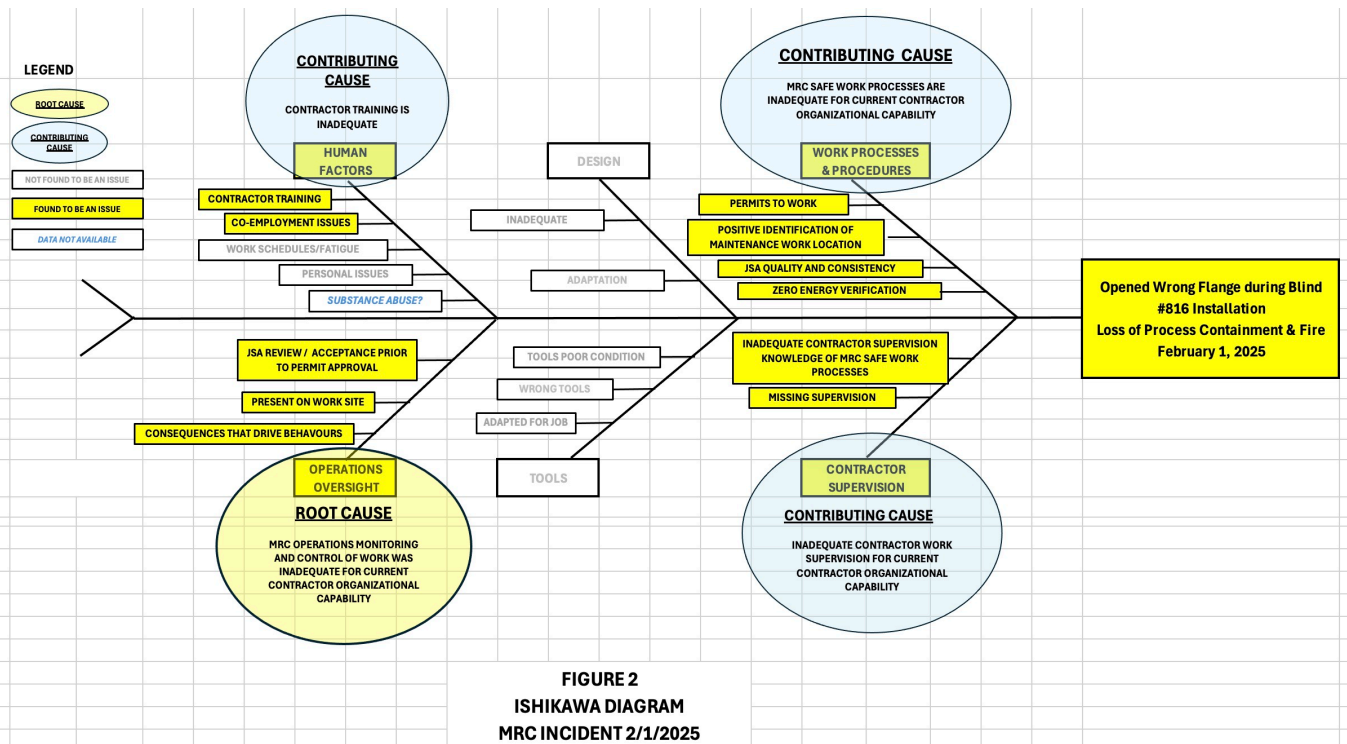
JEM Advisors used the fishbone/cause and effect diagram to identify the incident causal factors and root causes for this event as shown below.

Root Cause - MRC Operations Monitoring and Control of Work was inadequate for current Maintenance Contractor Organizational Capability

- Workers not observing the MRC blind tag, and opening of a flange outside of the zero-energy isolation boundary raise concerns for the level of experience and training of the workers performing the blind #816 blind installation. Several MRC personnel interviewed expressed a general concern over declining contractor worker experience levels.
- There are a number of factors which may impact Contractor maintenance worker selection, training, organizational capability, and performance. As owners of the facility, MRC operations must have effective procedures and processes in place to ensure the safety and performance of the refinery.

- Modify Permit to Work procedure to require MRC Operations to review and ensure adequacy of Contractor JSA prior to permit approval, to ensure workers understand the job risks, and that the highest risk hazards are properly mitigated (i.e. wrong flange for blinding, cutting wrong line, etc.). Do not approve Permit to Work until JSA meets these standards.
